Manhole Inspection Summary

Manhole # S35GG_001MH

Insp Date: **3/14/07 11:36 AM**

Location Address: **1501 LATROBE ST**

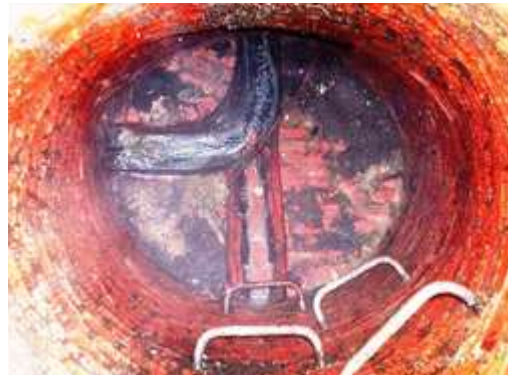
Top View

☐ Parged ☒ **Debris** (not Condition related)

Count: **5** Missing: **0** ☒ **Corroded**

☒ **Evidence Of Surcharge** Depth: **1** (ft.) ☐ Active Surcharge Present

Corroded steps. Evidence of surcharge - Bench debris.

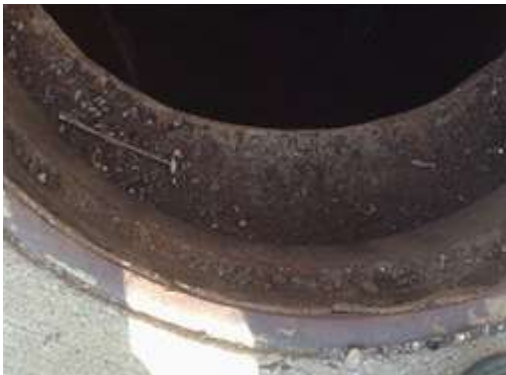
Defect

Offset: **4** (in.)

Frame offset.

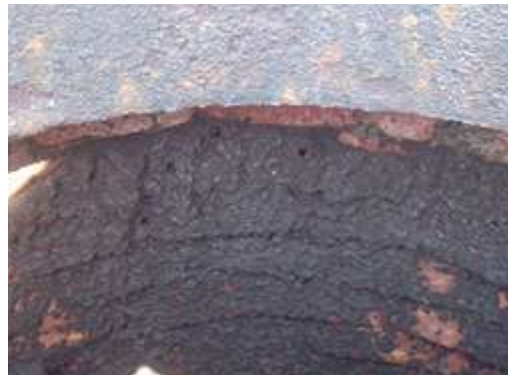
Defect

Infiltration: ☐ None ☒ **Joint** ☐ Cracks ☐ Mortar ☐ Roots ☒ **Wall**

Infiltration: ☐ None ☐ Joint ☐ Cracks ☐ Mortar ☐ Roots ☒ **Wall**

Adjustment and Corbel infiltration.

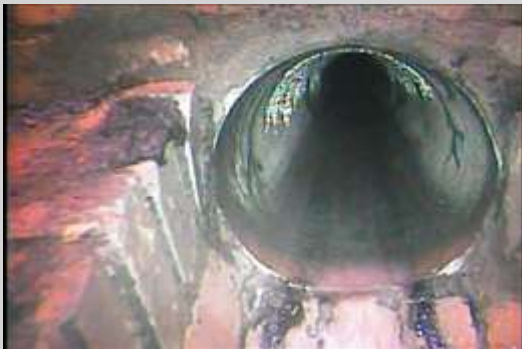
8 in. Circular Gravity Sewer Pipe In @ 6 O'Clock

Infiltration: **Evidence** Pipe Seal Cond: **Unknown**

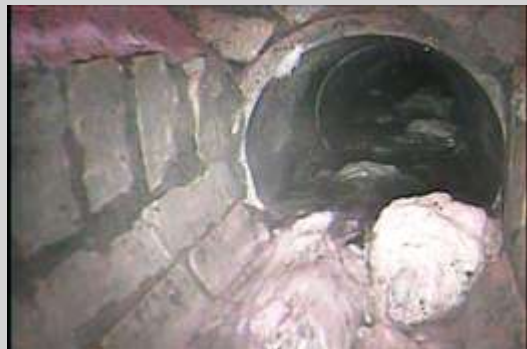
Pipe In @ 9 O'Clock

Deposits: ☐ None ☐ Mud ☐ Sludge ☒ **Debris** ☐ Grease

Silt Depth: **1** (in.)

Deposits Extent: **Light**
